# Potential Hazardous Waste Site

## Site Inspection Report

HOOKER ROAD BRIDGE DUMP  
TND 980844229  
Chattanooga, Hamilton County,  
Tennessee

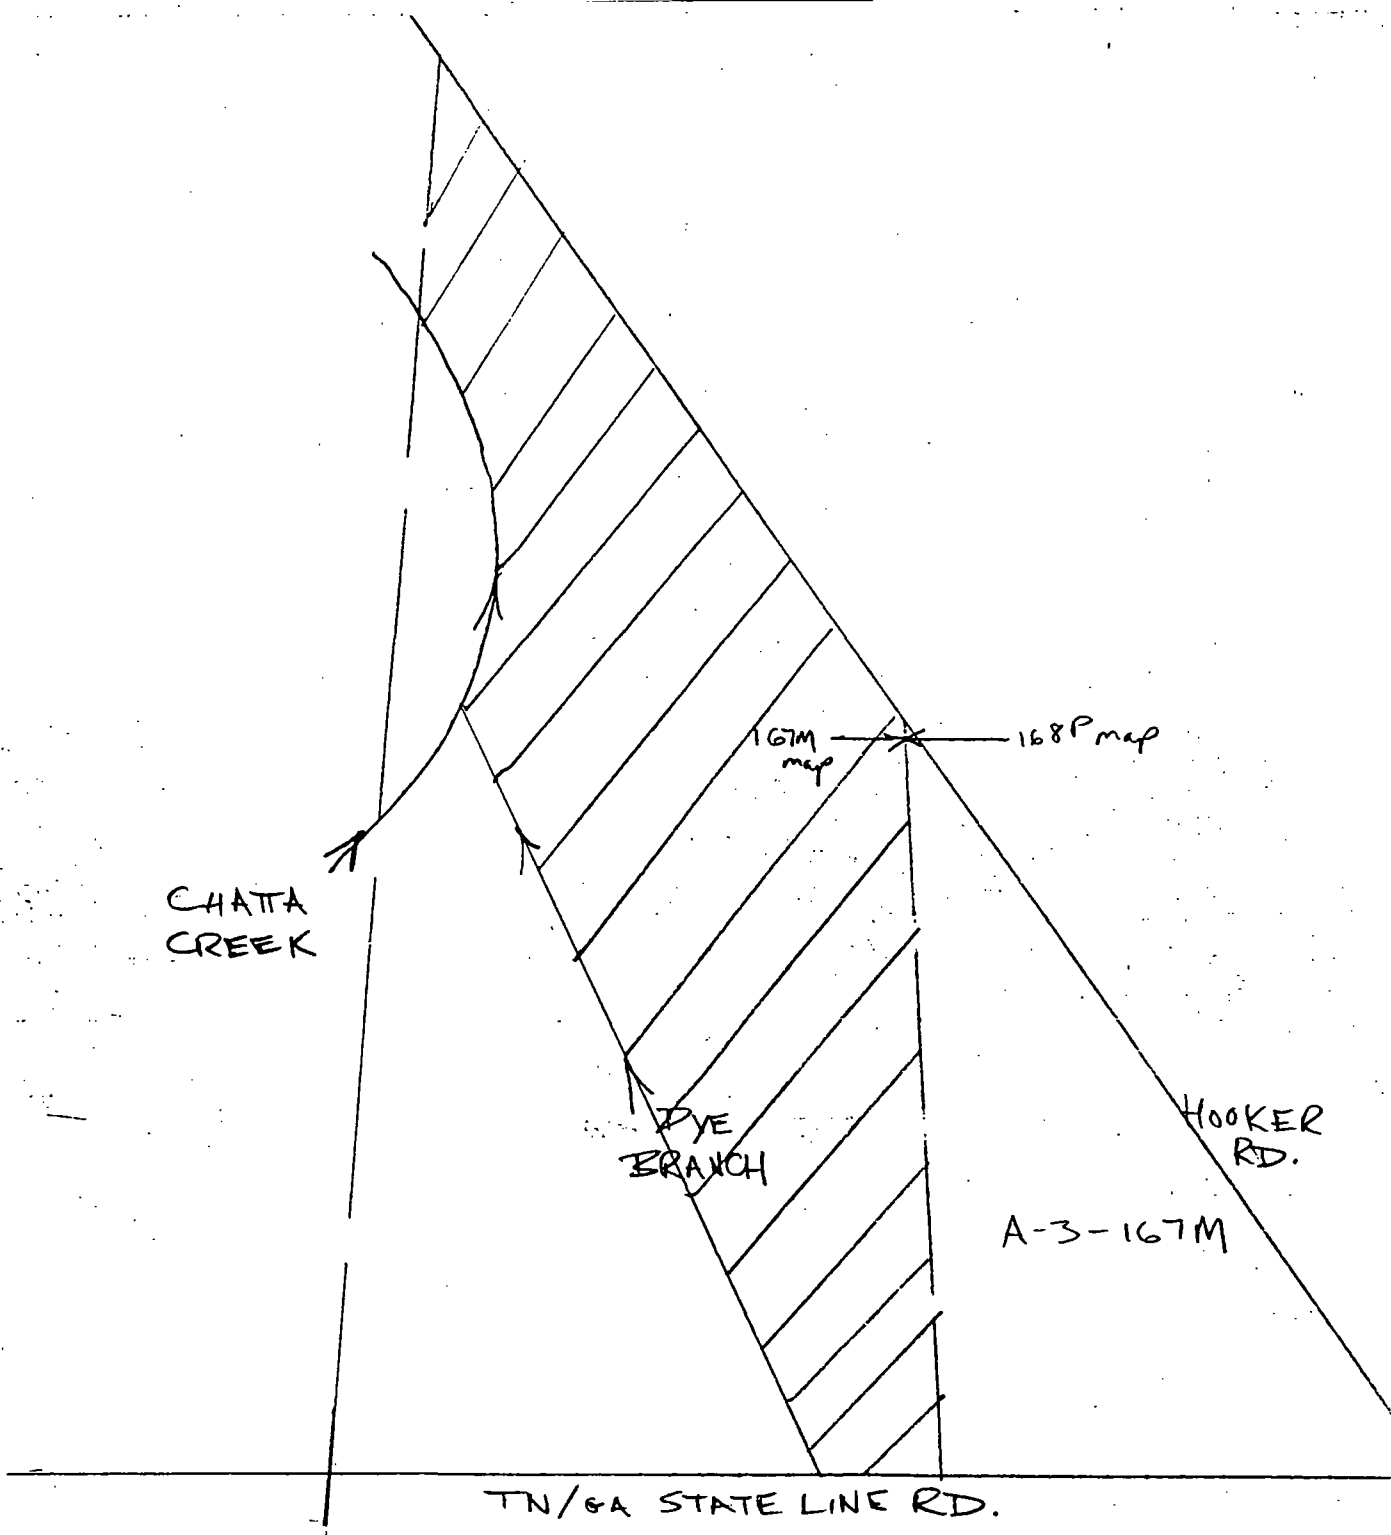
Composite of 2 Assessor's Office  
Maps - Hamilton Co, TN  
HOOKER RD, BRIDGE DUMP  
File #33590  
No Scale  
FDM 2 Mar 88

Site investigated is shown as ///

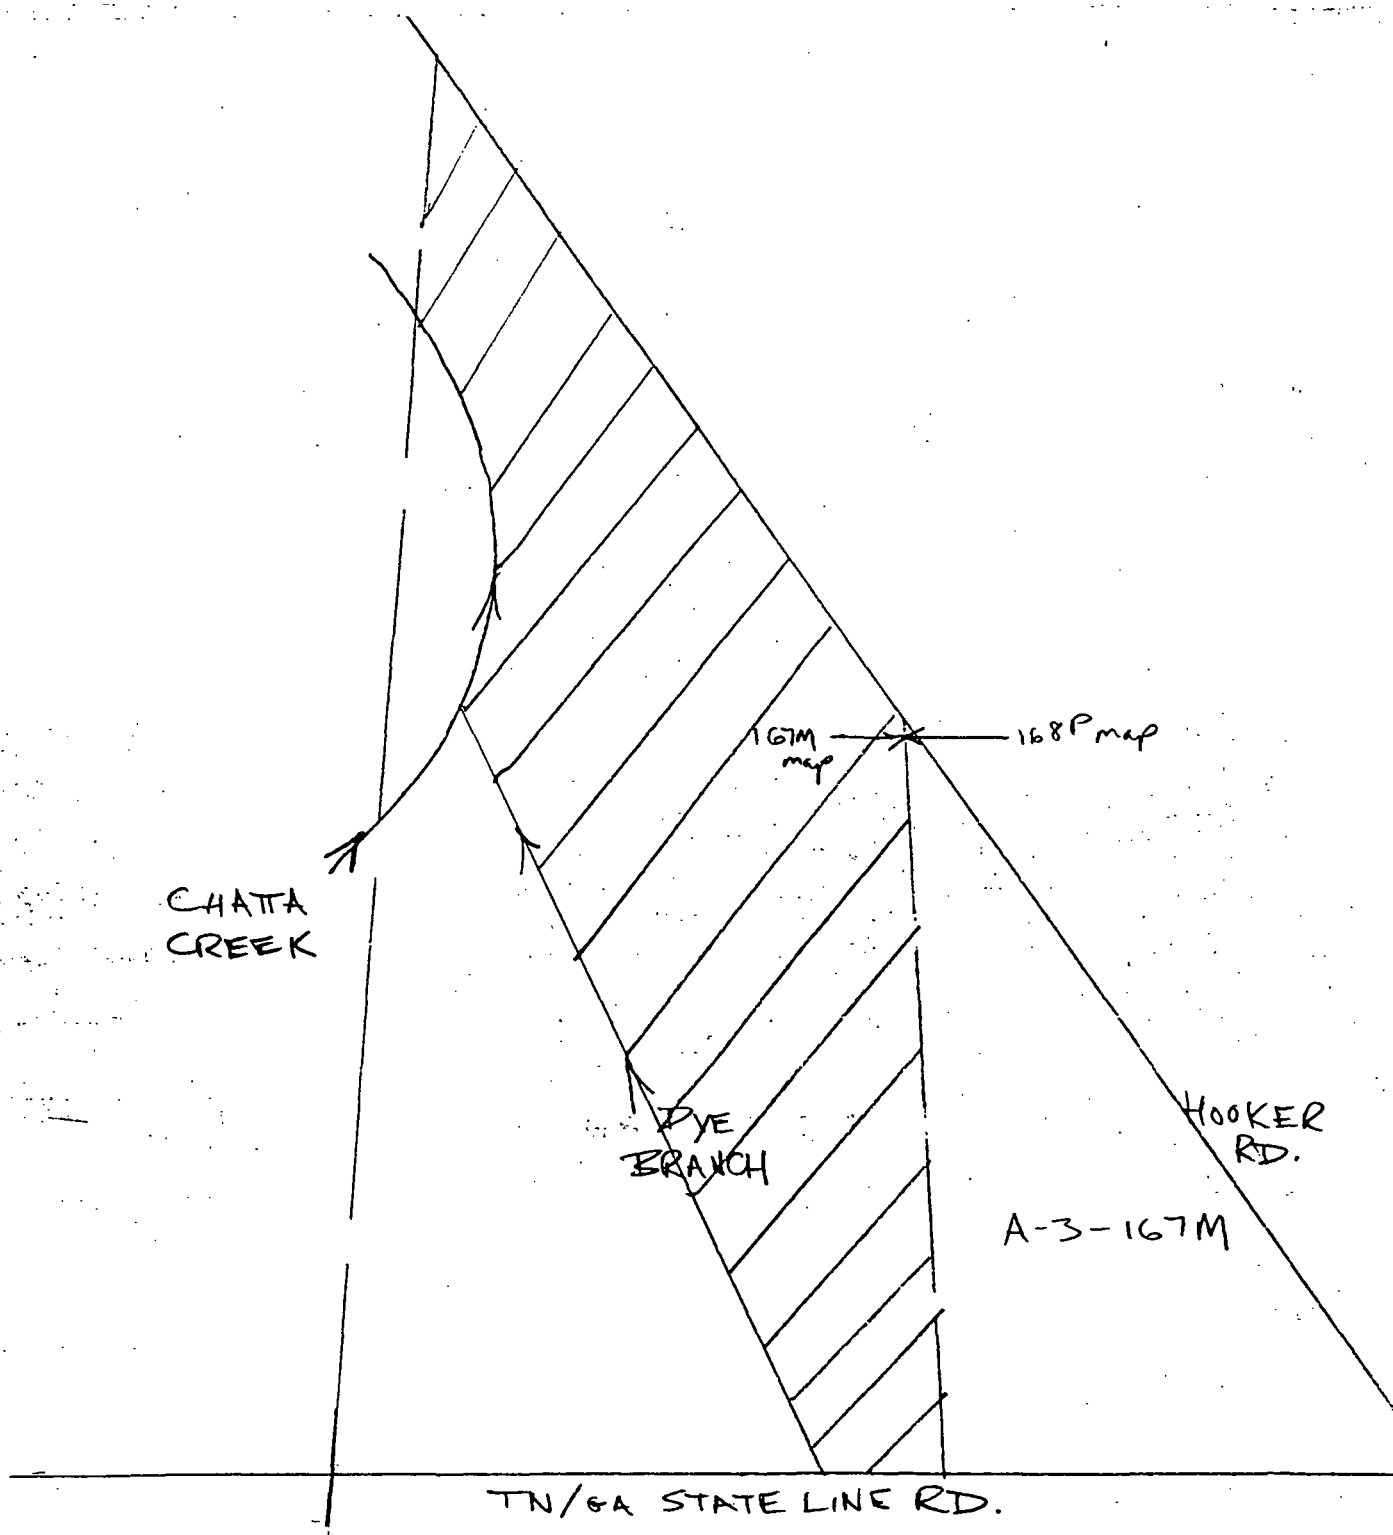
Composite of 2 Assessor's Office  
Maps - Hamilton Co, TN  
HOOKER RD, BRIDGE DUMP  
File #33590  
No Scale  
FDM 2 Mar 88

Site investigated is shown as ///
